The experiment progress of bracket brazing to SSMIC for the ITER ELM prototype coil

The Institute of Plasma Physics of Chinese Academy of Sciences, P.O. Box 1123, Hefei, Anhui 230031, PR China

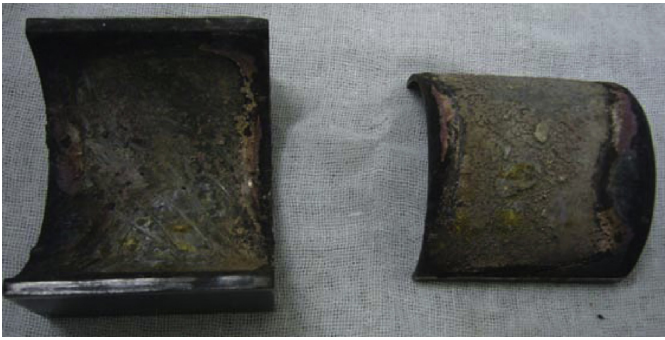
Fig. 4. The experiment result of bracket sample with the pure powder as the filler.

The three brazing fillers with the copper powder is filled into the three bracket samples uniformly and heating in the 640 °C oven for 1 h. According to the brazing results shown in Fig. 4, the brazing is failure and the probably reason is that the copper powder is easy to oxide in the non vacuum brazing environment. So the copper powder is not suitable to be as filler for bracket brazing in the present brazing condition.

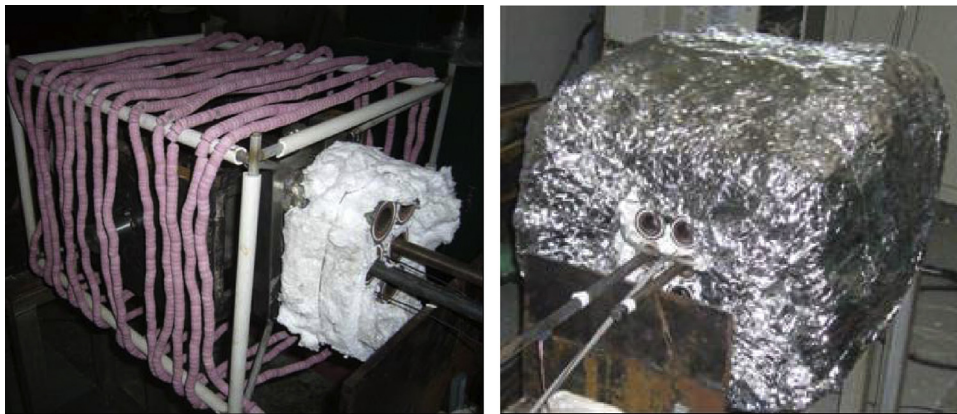
Fig. 9. The heating oven assembly process for bracket brazing.

- (4) The heating oven assembly process which includes the frame, heating resistor and high temperature adiabatic fibers assembly shown in Fig. 9;
- (5) The last is the heating brazing process.

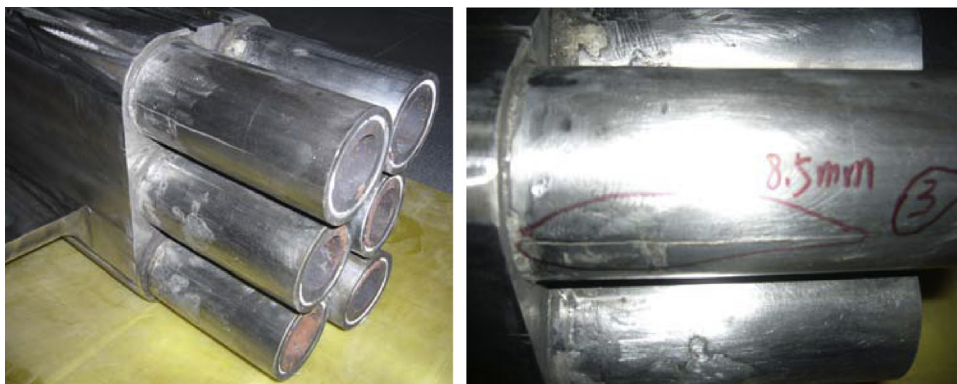
Fig. 12. The cracks in the jacket surface.

The brazing performance seems good by visual, but some cracks appear on all jackets surface unexpectedly. The all cracks seem to spread from inside to the outside shown in Fig. 12.

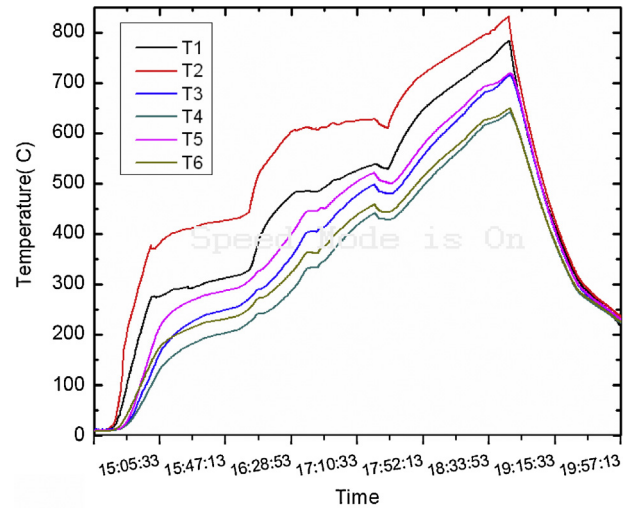
Fig. 19. The typical bracket brazing curve for the prototype ELM coil racks in the jacket surface.

The typical bracket brazing curve for the prototype ELM coil shown in Fig. 19. Where T1 and T2 is the air temperature in the top and below of the bracket, T3–T6 is the bracket temperature in the different location.
